Minimum Material Requirements

Friction Performance Factors

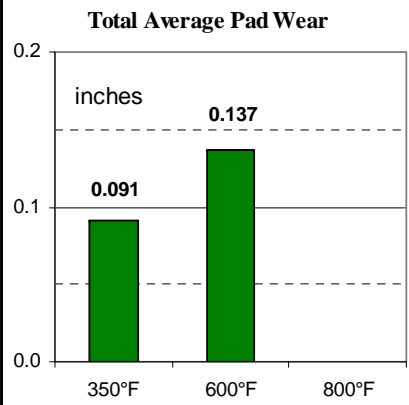
Pad and Rotor Condition		
	Inner	Outer
Cracking	10.0	10.0
Edge Erosion	8.0	8.0
Pad Surface	8.0	8.0
Rotor Condition	9.0

Comments: Did not complete test. Aborted before 800°F Wear Section due to excessive wear.

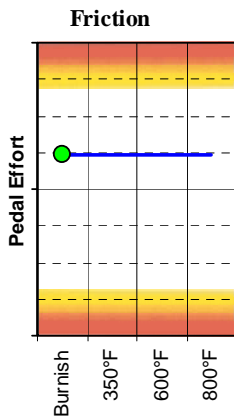
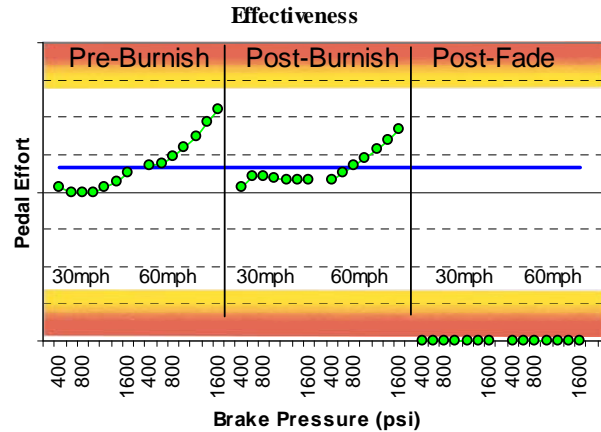
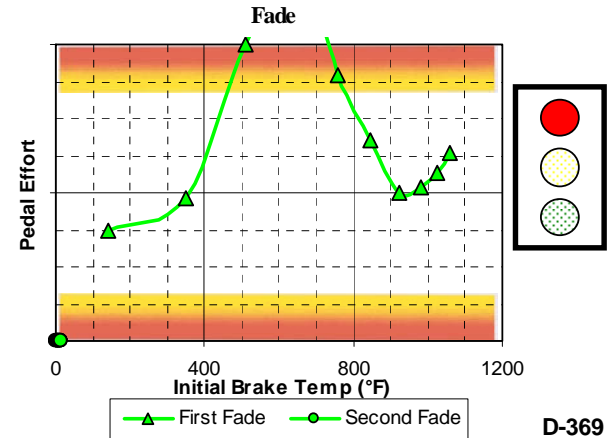
Comments: Test aborted after first fade due to low friction. Material unable to maintain deceleration setpoint.

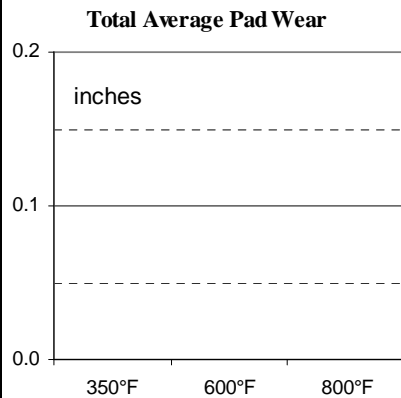
Pad and Rotor Condition	
Inner	Outer
Cracking	
Edge Erosion	
Pad Surface	See Photos
Rotor Condition

Comments: Did not attempt or complete wear sections of test due to friction level and integrity of pads.
